## Aquatic Plant & EWM Bed Survey Report

Sauk County, Wisconsin

SubPI Surveys of Cardinal, Chippewa, Fox Court  
Oriole, & Swallow Bays August 5<sup>th</sup>, 2024

EWM Bed Survey September 9-11<sup>th</sup>, 2024

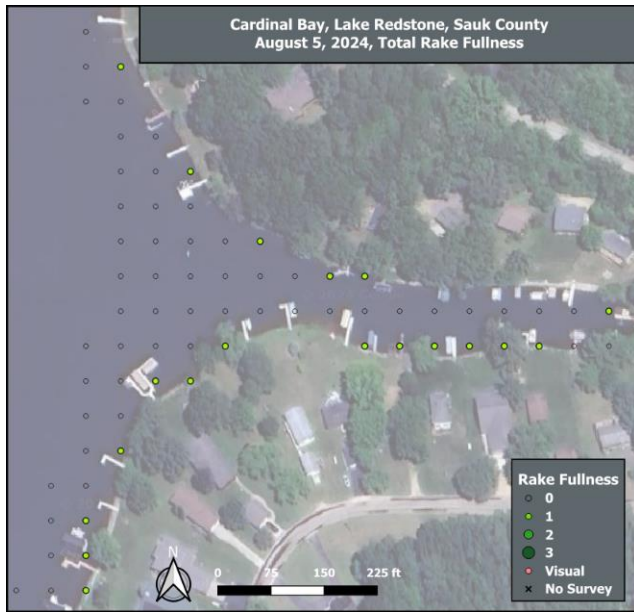
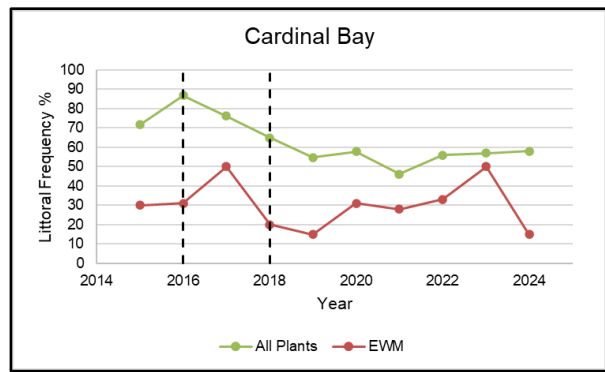
- Max rooting depth = 5ft (11 feet in 2023)
- 58% Littoral frequency all plants.
- Plant occurrence is lower than 2023.
- Most common plant was wild celery at 10 sites. There were more native plants than EWM in Cardinal compared to past years.
- Chi-squared tests<sup>2</sup> revealed a statistically significant decrease in coontail and EWM in 2024 compared to 2023. There was a statistically significant decrease in coontail, EWM, slender waterweed, and filamentous algae when comparing 2015 data to 2024. EWM chi-square graph is in the EWM Section.
- Cardinal Bay is NOT designated as a critical habitat area

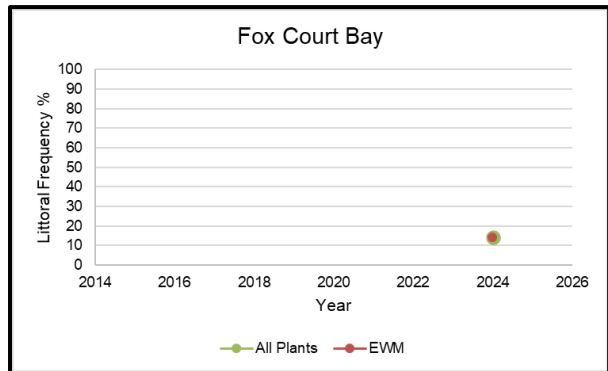
- Max rooting depth = 3.5 ft.
- 14% Littoral frequency.
- This bay was surveyed to due to EWM concerns. There was reportedly one area with high EWM occurrence in 2024 among the 4 docks along the northwestern shoreline. The EWM in that area was manually removed by property owners before the survey occurred. Manual removal in shallow areas is currently the best approach for small-scale EWM control on Lake Redstone.

- No chi-square analysis was completed for Fox Court Bay because 2024 was the first year of subPI surveys.
- EWM was the only plant detected and it was found on the rake at 1 sample point. Low plant occurrence was likely due to the limited sunlight in the narrow section of the bay and deeper water in the central area of the bay. Future subPI surveys of Fox Court Bay is not recommended. EWM bed surveys or photos of EWM before and after hand pulling would be a better approach for this bay.

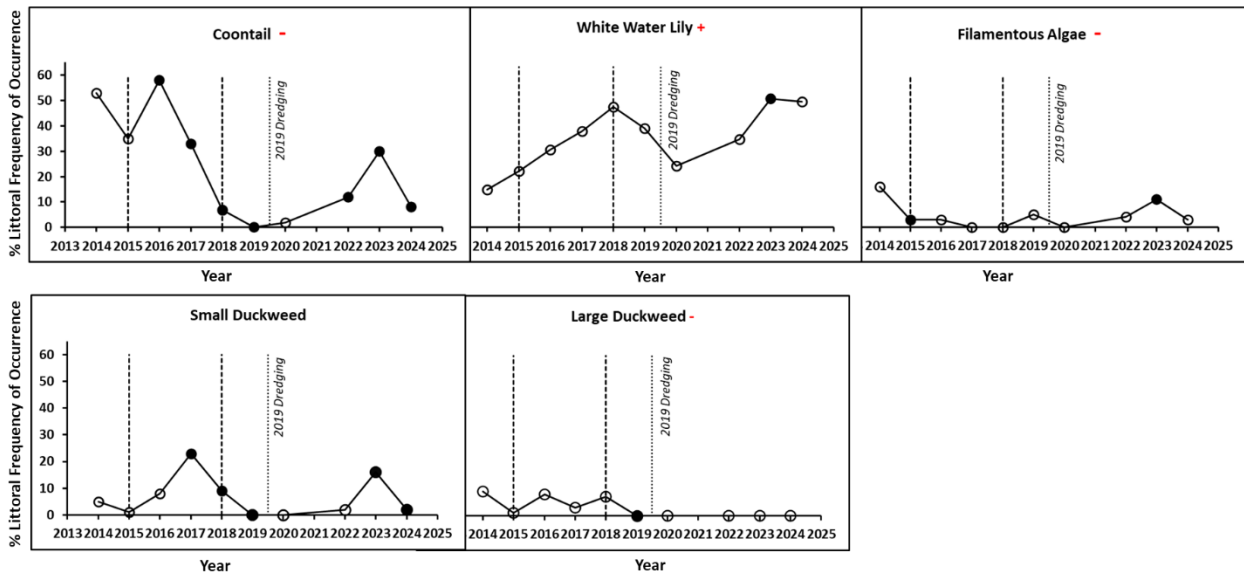
#### Swallow Bay 2014-2024

- Max rooting depth = 5ft (same in 2023)
- 48% Littoral frequency all plants (61% in 2023).
- Most common plant was white water lily at 28 sites (2023 was 29 sites).
- Chi-squared tests<sup>2</sup> revealed a statistically significant (SS) decrease in EWM, coontail, and small duckweed in 2024 compared to 2023. There was a SS decrease in coontail, EWM, large duckweed, and filamentous algae when comparing 2014 data to 2024. There was a SS increase in white water lily in 2024 compared to 2014. EWM chi-square graph is in the EWM Section.
- Swallow Bay is designated as a critical habitat area.

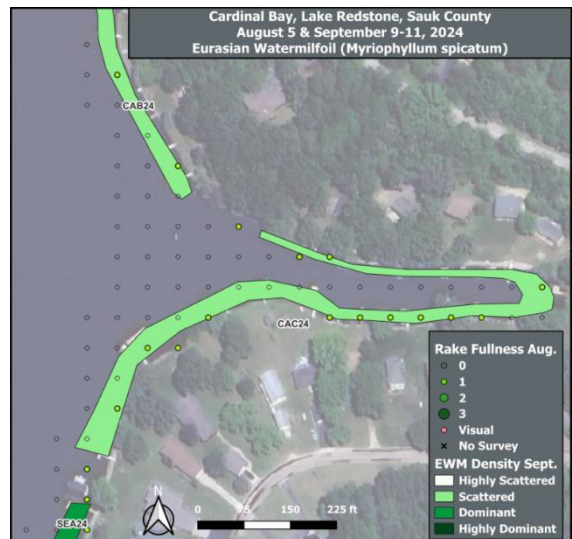
**Figure 3 - Cardinal Bay Eurasian Watermilfoil Map & Chi-Square Graph**

- EWM was the fourth most common plant with occurrence at 5 sites (another 6 visual).
- Herbicide was applied in Cardinal Bay in 2016 and 2018.
- Navigation impairment caused by EWM was not observed in 2024. There was a clear channel down the middle of Cardinal Bay allowing for navigation. The near shore areas between docks had greater EWM occurrence and density, likely causing some nuisance for near-shore areas.
- A chi-squared test of EWM revealed a statistically significant decrease in EWM between 2015 and 2024 and between 2023 and 2024.

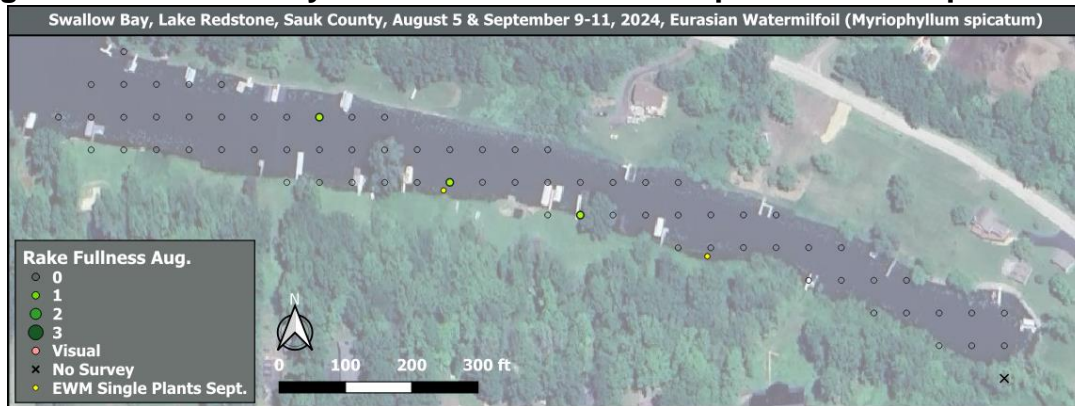
**Figure 6 – Swallow Bay Eurasian Watermilfoil Map 2024 & Chi-square Graph**

- EWM was found at 3 sites (0 visual), third most common plant species in 2024.
- Herbicide treatment was done in 2015 & 2018 to control EWM.
- Chi-squared tests<sup>2</sup> revealed a statistically significant decrease in EWM in 2024 compared to 2023 and when comparing 2014 data to 2024.
- Navigation impairment caused by EWM was not observed in 2024. There was a clear channel down the middle of Swallow Bay allowing for navigation.
